**Evidentiary Report of Possible e-Stewards® Critical Non-Conformity**

**Universal Recycling Technologies**

**February 26, 2024**

**Case Number:** 12-05-24-01

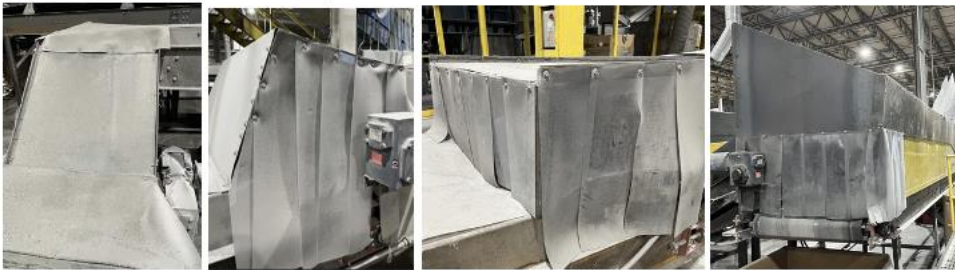
- b. Transition points throughout the return conveyor were enclosed and sealed preventing dust escapes at each of the 6 transition points from the sieler room to the hammer mill room

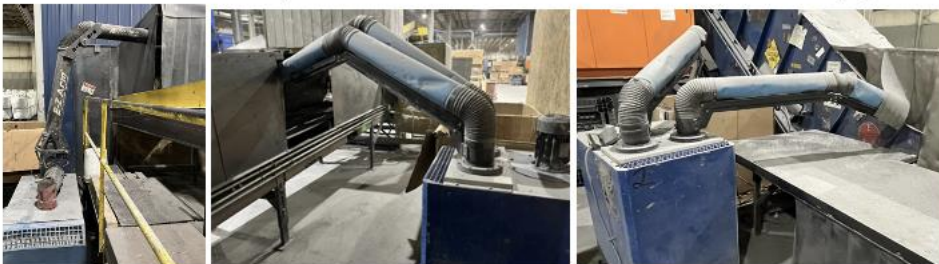
- c. Remote dust collection units were installed at high exposure points (4 total remote dust collection units were installed and placed in locations in addition to the current HVAC drops)
